RE: Apartment Deck Repair Assessment
Section I of IV

Site Address: 222 Beautiful Road, Santa Cruz
Report Title: Report of Findings from Inspection of 206 Decks

Apartment Deck Repair Assessment - Section IV (Abridged Sample of Photos)

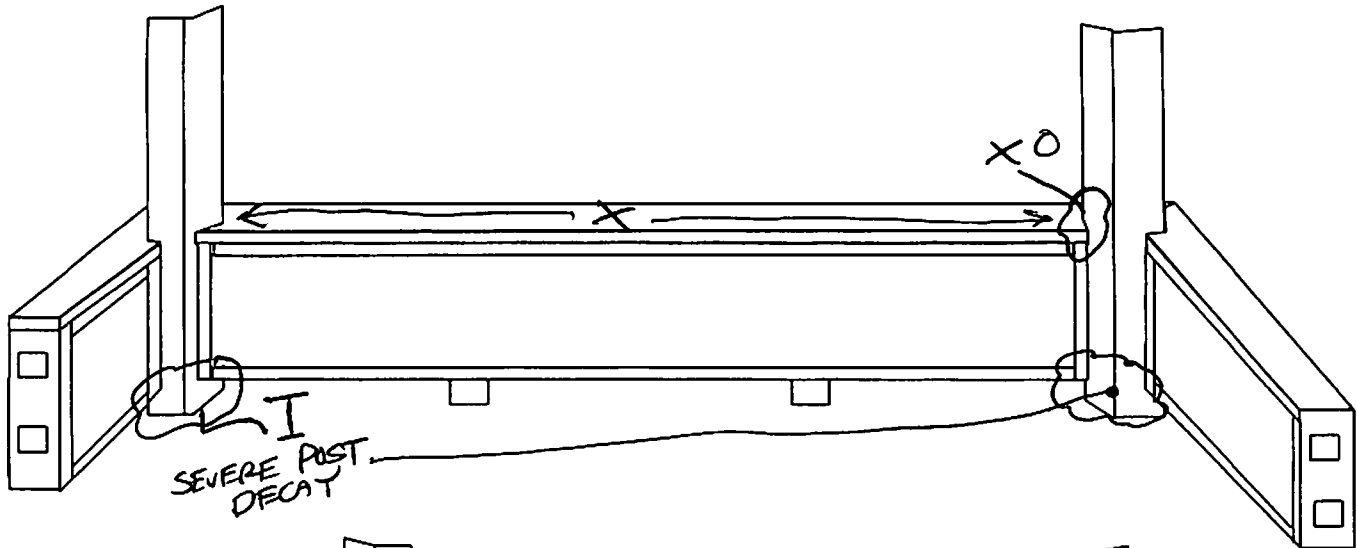
Figure 1 - Interior

Lower corner solid railing (left long wall) and

Rating: 5
