## Multi-unit Buildings - Exhibit A

The Director of Facilities of a retirement community hired us to do a survey of 206 private decks in a multi-unit complex, to determine which ones were in need of repair and to what extent.

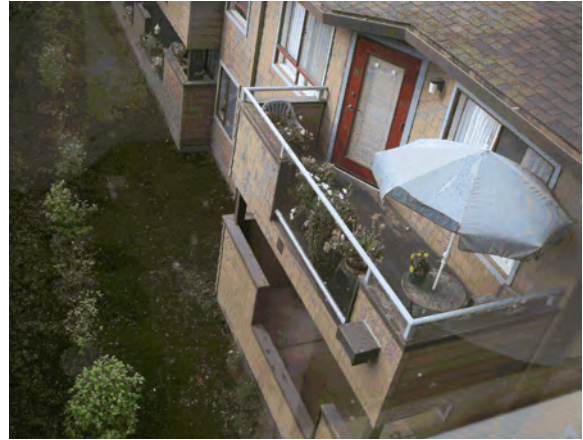
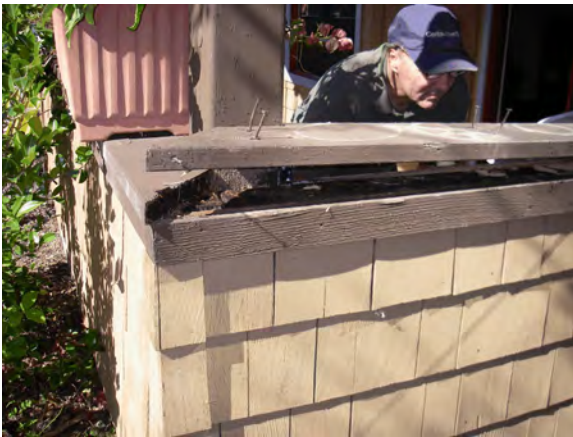
We found that over 50% needed either major framing and finish carpentry repairs, or required immediate framing repairs for safety issues.

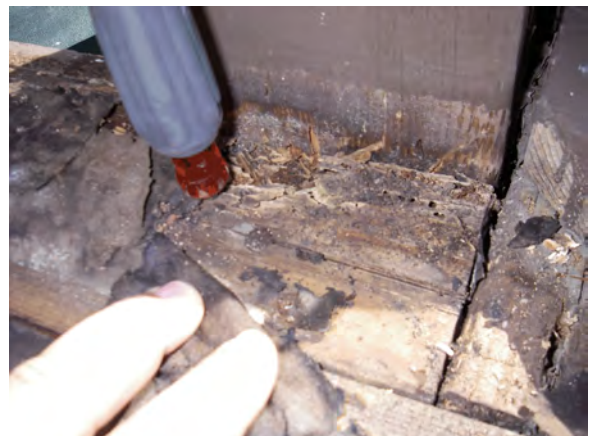
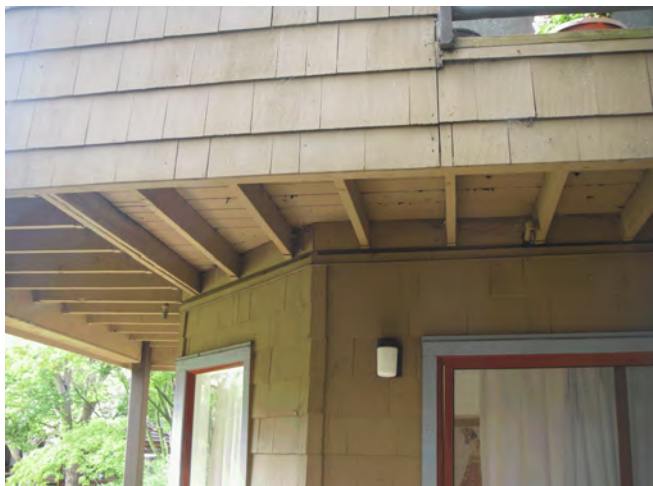
MFC discovered fungus, rot, pest infestation, and other issues during our inspections.

In the end, the Facilities Director had a concrete plan of which decks to prioritize for work first, as well as where to fix them so they would be safe.
