Residential - Exhibit A

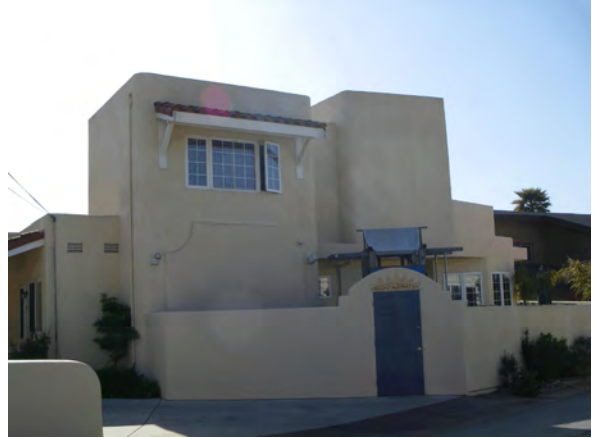
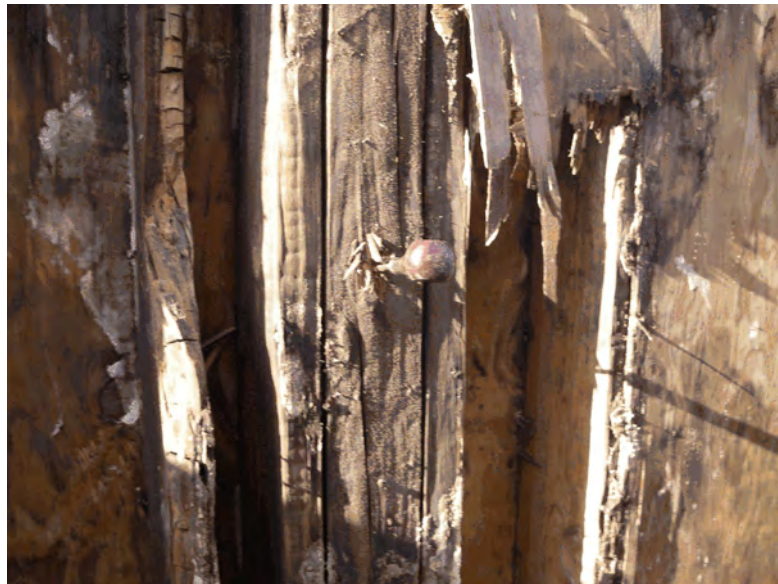
Rot and mildew destroyed the framing underneath the improperly installed stucco and windows.

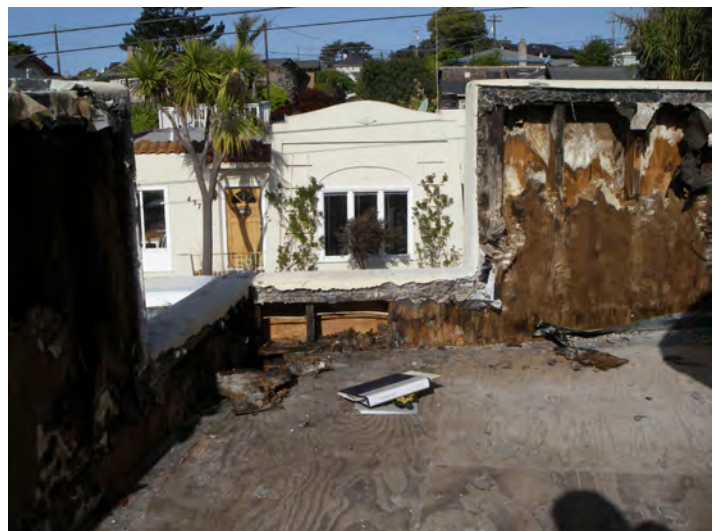
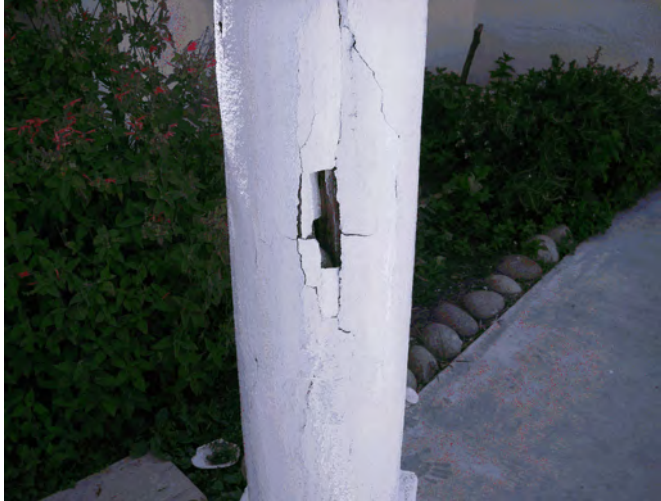
Rotted columns which again looked fine to the eye. Upon MFC's further inspection, we discovered the wood underneath the stucco was rotted through and unsafe.

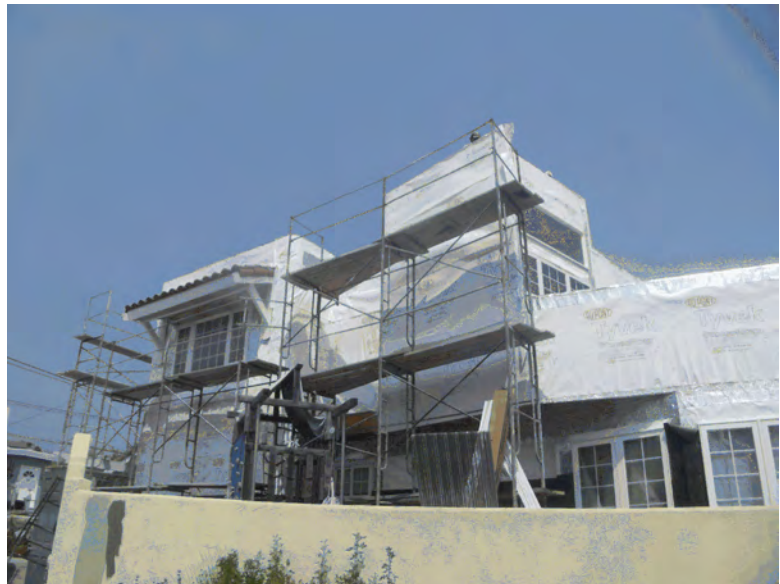
Corrected waterproofing and stucco techniques.

MFC was onsite during the rebuild to assure that our repairs details were implemented correctly.

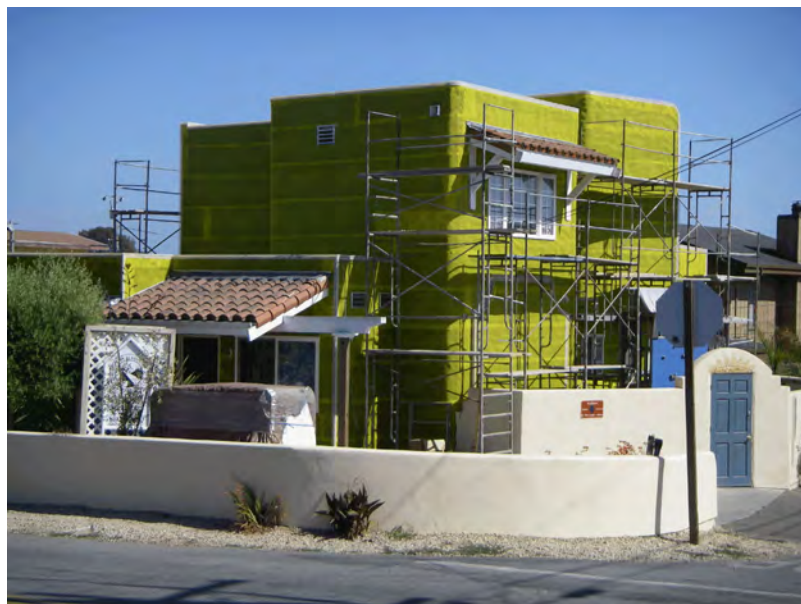
The lath installation.
