Commercial - Exhibit A

A contractor asked us to develop details to repair a large deck over a health facility clinic. Repairs for a persistent leak had been attempted unsuccessfully numerous times. MFC not only found the source of the deck leak, we also found additional damage to exterior stairs and deck walls. We designed a cost effective fix.

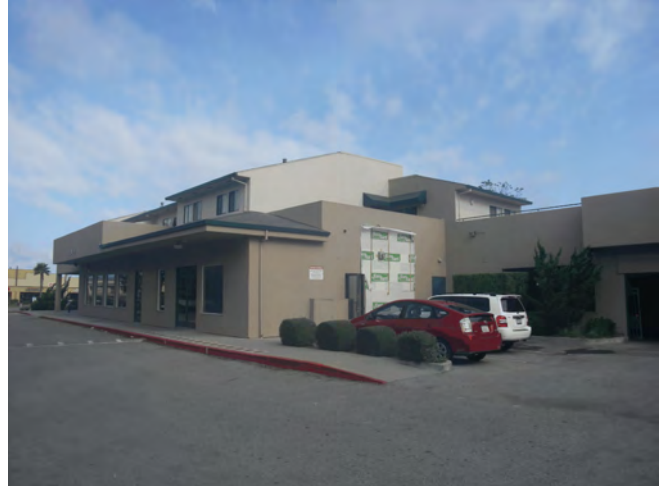
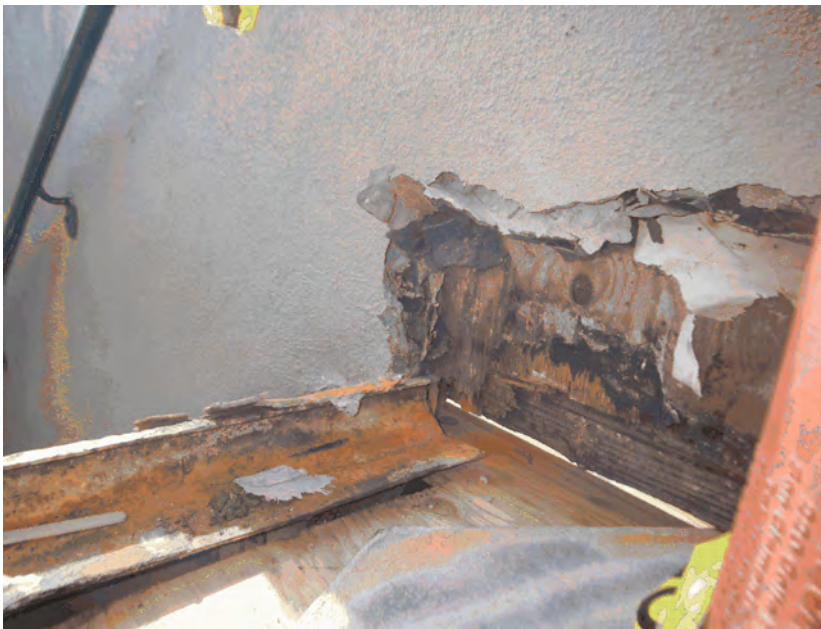
To the eye, these stairs looked fine, but once we inspected we found evidence they sustained water damage and rot to the frame as well.

The rot under the deck and stairs undermined their strength, and therefore their safety, of this public health care facility.
