Commercial (exhibit C)

The attorney for a food manufacturer contacted us to inspect a warehouse their client had leased in Salinas. They were defending a law suit from the property owner. We were asked to determine if their client's use, including powerful washing equipment, had caused the damage to the ceiling and fire sprinkler system and if so, what percentage. We were successful in demonstrating that their client's use

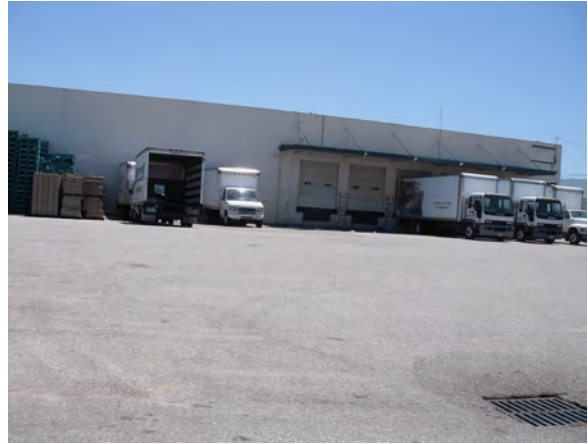
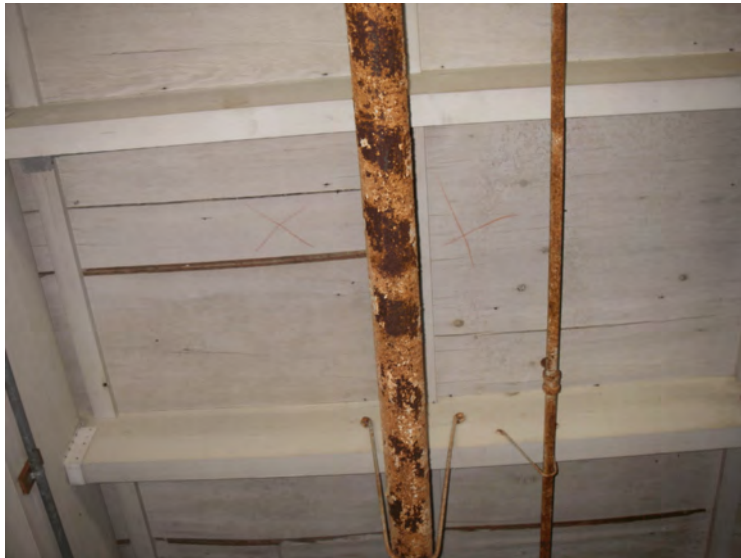
Ceiling panels were delaminated and sprinkler pipes were rusted. However, MFC showed that the pattern of damage suggested it wasn't due to our client as it was worst along a wall on the far side, not nearest to the power washing machine.

was not the main cause of the damage, rather it was due to a wall that was erected by the owner which inadvertently disrupted the ventilation.
