MFC NEWS

Summer 2015

Considering the Berkeley Balcony Collapse

By Myles F. Corcoran

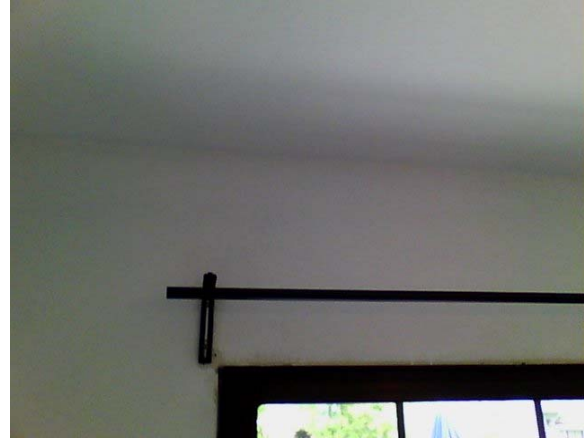
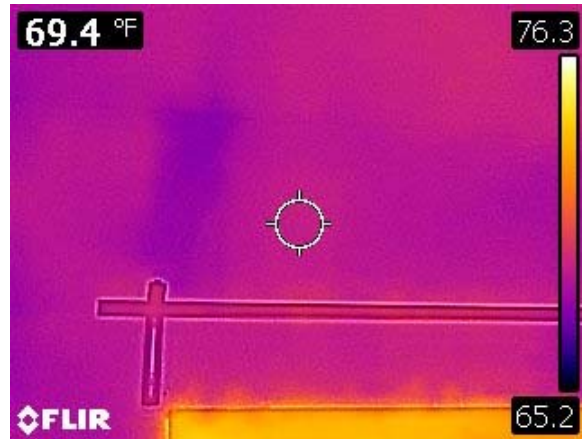
Can you see the leak?

Now, can you see the leak?

A thermal imaging camera is great for detecting moisture quickly. Moist, porous materials typically will be cooler than dry ones. This fact allows the camera to show the user where moisture is hiding. The same can be done using traditional moisture meters, however the camera is much more efficient as it enables the user to view a broader area and takes a lot of the guesswork out of finding hidden leaks.

MFC now offers thermal infrared
imaging as part of our inspections and
water test. We recently added a Flir
Thermal Imaging camera to our tool
crib which will allow our Consultants to
find the source of water intrusion more
efficiently.

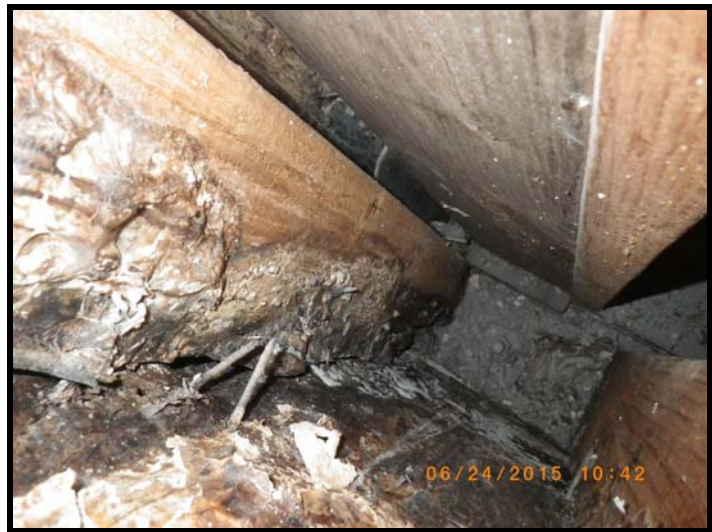
Photo taken after removing the perfectly fine stucco finish of a 3 year old structure in May 2015. This is the support frame for the floor above.

Wood is organic and fundamentally soft, even when it has been processed into plywood, oriented strand board (OSB), structural members or any other structural part. Molds and fungus devour wood which can disintegrate structural components in remarkably short time.

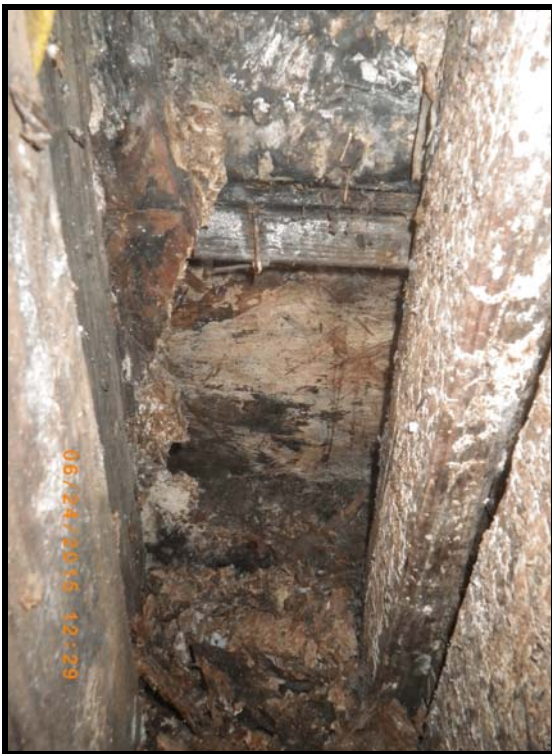
This is the opposite side of the same building, also on the 1st of two floors.
